### 2007-Efectis-R0009[Rev.1]

Determination of the fire resistance according to EN 1365-2:1999 of a suspended ceiling system of CMC with Rockfon Sonar D 900 x 900 concealed ceiling tiles, suspended under an aerated concrete floor supported by steel sections

Project name Fire resistance floor ceiling construction  
Project number 2006058/101

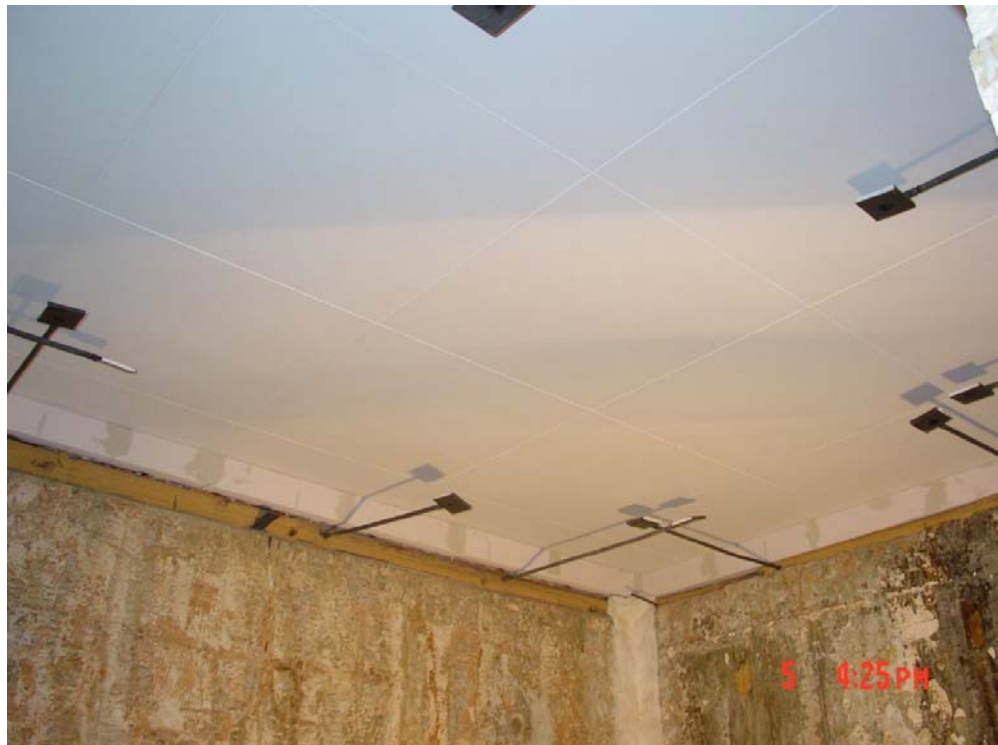
Figure C2 Specimen from the heated side before the test

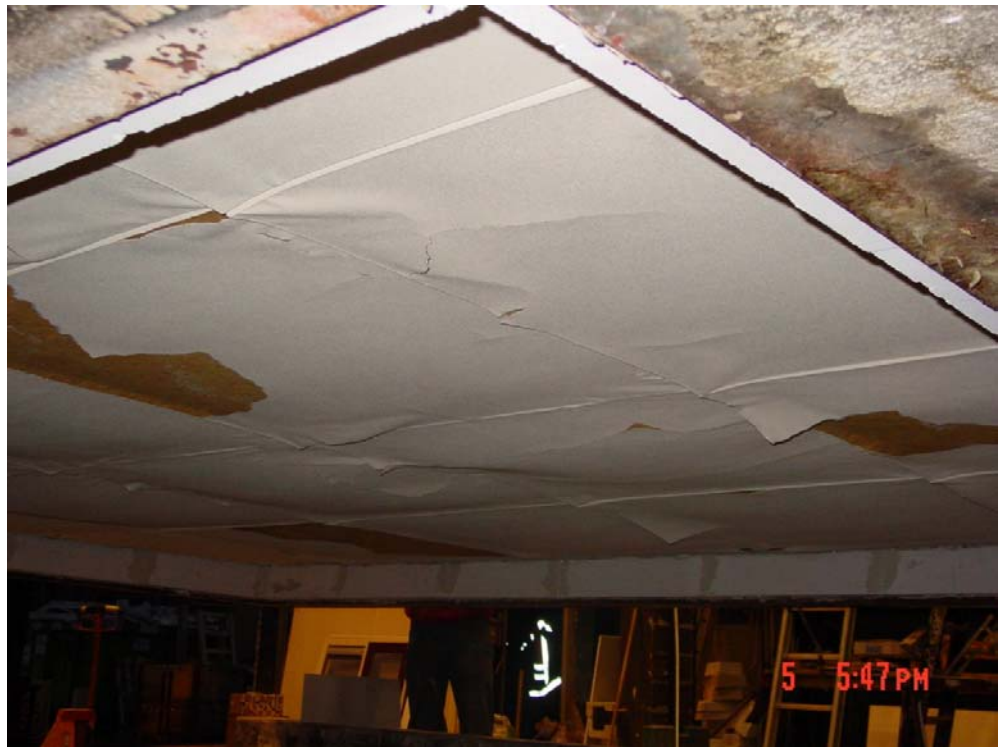
Figure C3 Specimen after the test looking into the cavity

Time [min]	Observation
0	Start of heating.
5	The wall profiles deform
7	The fire breaks are working
11	The fire breaks are pushing the tile out of shape
20	All criteria are met
30	All criteria are met
37	Of one tile the mineral fleece is becoming detached from the tile
48	The end of the heating after consulting the sponsor. All tiles are still positioned in the grid
