### 2006-Efectis-R0462[Rev.1]

Determination of the fire resistance according to  
EN 1365-2:1999 of a suspended ceiling system of  
CMC with Rockfon Sonar E24 600 x 600  
Shadowline ceiling tiles, suspended under an  
aerated concrete floor supported by steel sections

Project name Fire resistance floor ceiling construction  
Project number 2006058/101

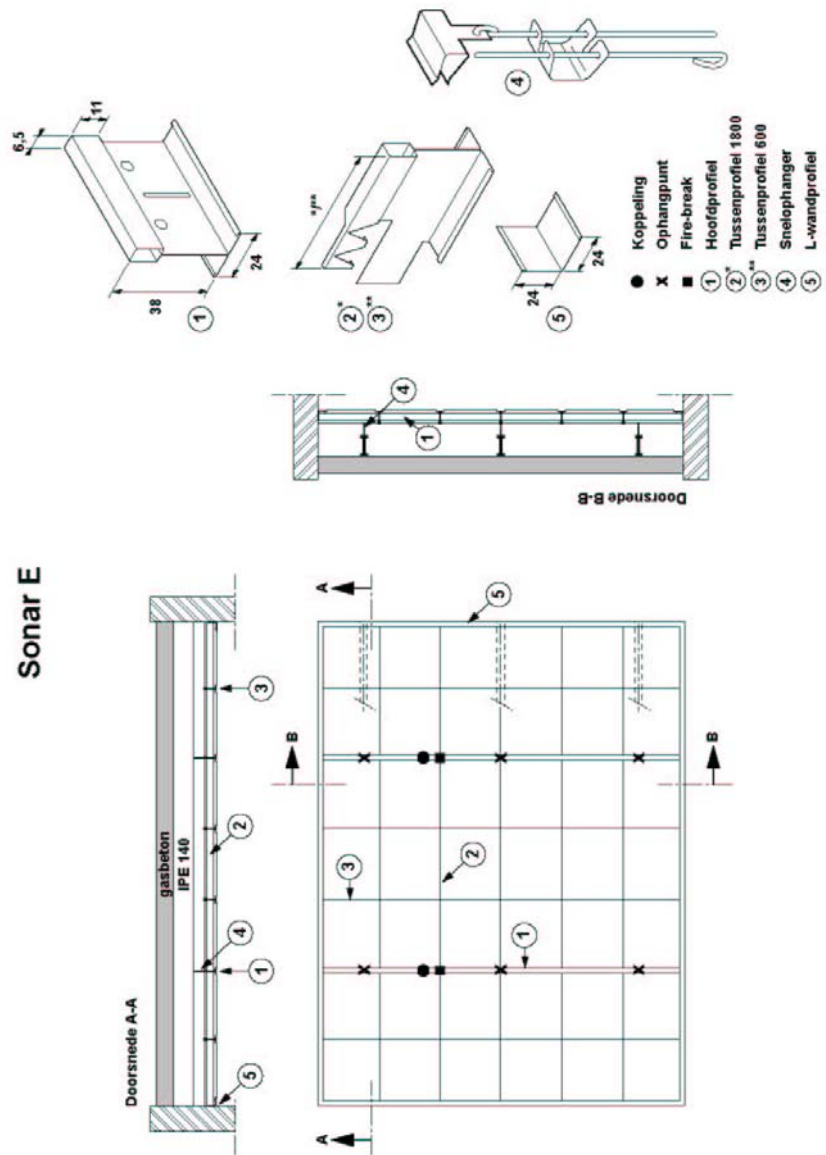
Figure 12.1 Overview of the test set up

A floor ceiling construction was the subject of the investigation. The build up was of reinforced aerated concrete floor members supported by steel sections IPE 140 with a suspended ceiling system of CMC 850, measurements 3.2 x 4.0 m, see figure 12.1. The ceiling tiles are produced by Rockfon and of the type Rockfon Sonar E24 Shadowline with the module size 600 x 600 x 20 mm.

- (1)<sup>1</sup>: Main profile of the type CMC 850-10-001 main measurements 38 x 24 with a material thickness of 0.4 mm.
- (2): Intermediate profile of the type CMC 856-30-001 main measurements 38 x 24 mm length 1800 mm, material thickness of 0.4 mm.
- (3): Intermediate profile of the type CMC 852-30-001 main measurements 38 x 24 mm length 600 mm, material thickness of 0.4 mm
- (4): Quick suspender of the type CMC 11000, existing of two parts steel wires Ø 4 mm and a coupling.
- (5): Wall profiles of the type CMC 1420, main measurements 24 x 24 x 0.6 mm.

The main profiles were connected to the quick suspenders (4), the positions are given in figure 12.1.

Each main profile was provided with one fire-break and a length connection, see figure 12.1. Also the intermediate T-profiles had fire-breaks.

- Steel nails galvanic ally zinned, measurements  $\varnothing 3.5 \times 60$  mm, c.t.c. approximately 250 mm, for fixing the wall profiles (5) to the aerated concrete frame.
- Caddy clip of the type 4-H-24, for the positions see figure 12.1.

The build up of the construction is given in figure 12.1.

- Placing the wall profiles (5) on the inside of the aerated concrete frame at a distance of approximately 400 mm from the bottom of the floor slabs fixed with steel nails with a c.t.c. distance of approximately 250 mm.
- Placing the Caddy clip and quick suspenders (4) to the IPE 140 sections, c.t.c. 1800 mm crosswise the span of the steel sections, see figure 12.1.
- Shortening the main profiles (1) to lengths of approximately 2434 and 766 mm.
- Connecting the main profiles and placing them to the quick suspenders (4).
- Adjusting the quick suspenders to correct length.
- Intermediate profiles (2 and 3), c.t.c. 600 and 1200 mm.
- Placing of the ceiling tiles.

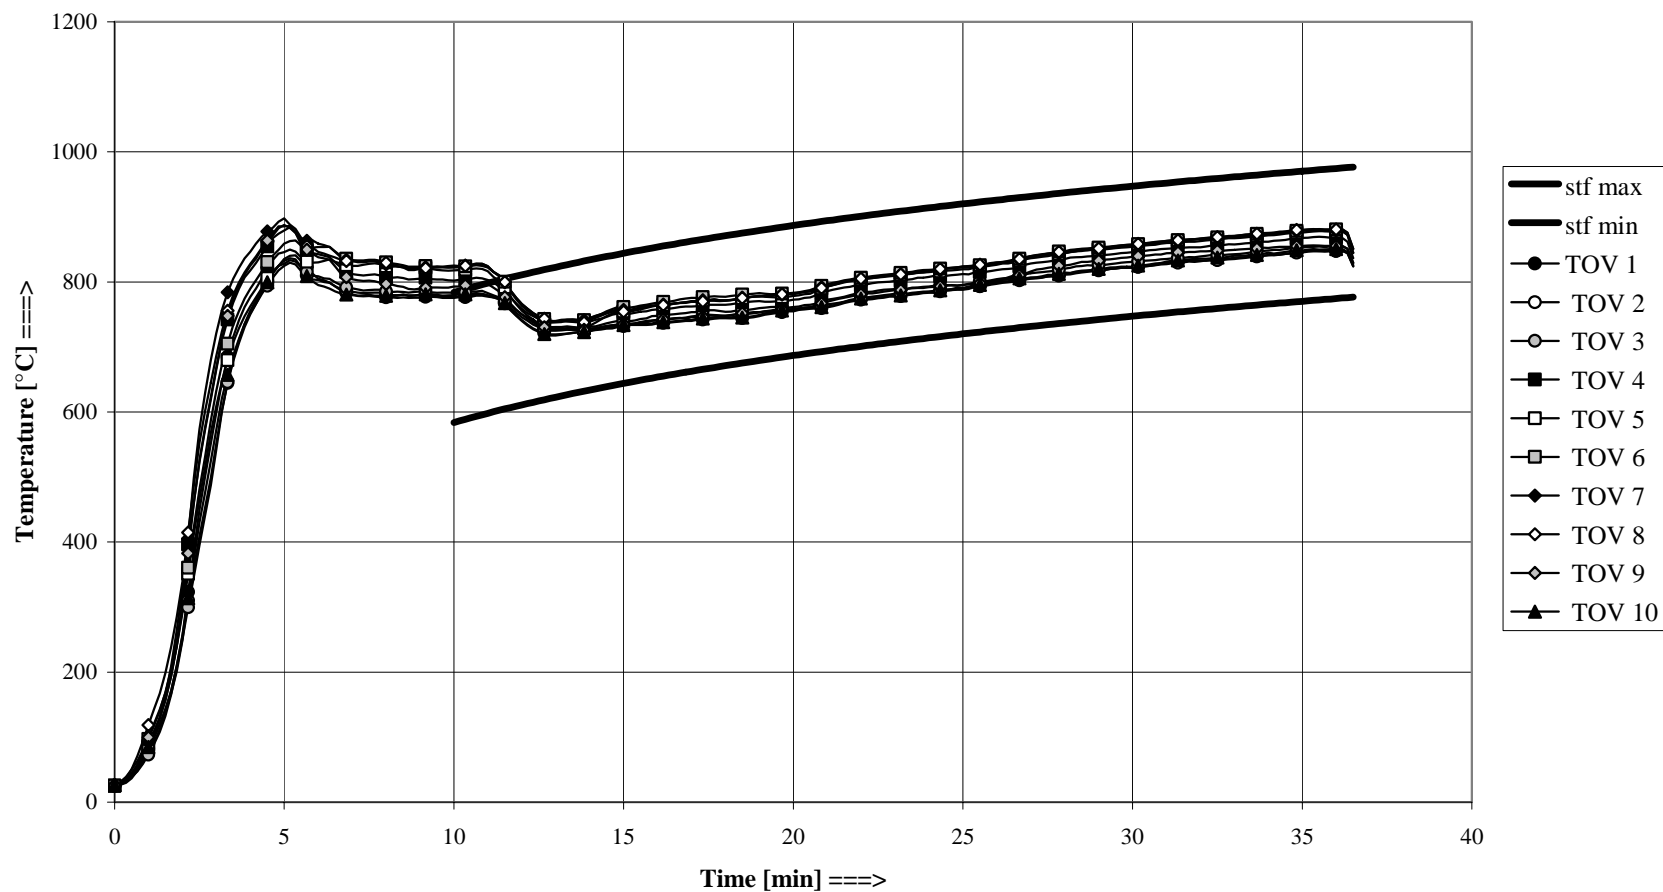
Figuur B2: Furnace temperature

During the heating the temperature and airspeed fulfilled the requirements of EN 1365-2: 1999.

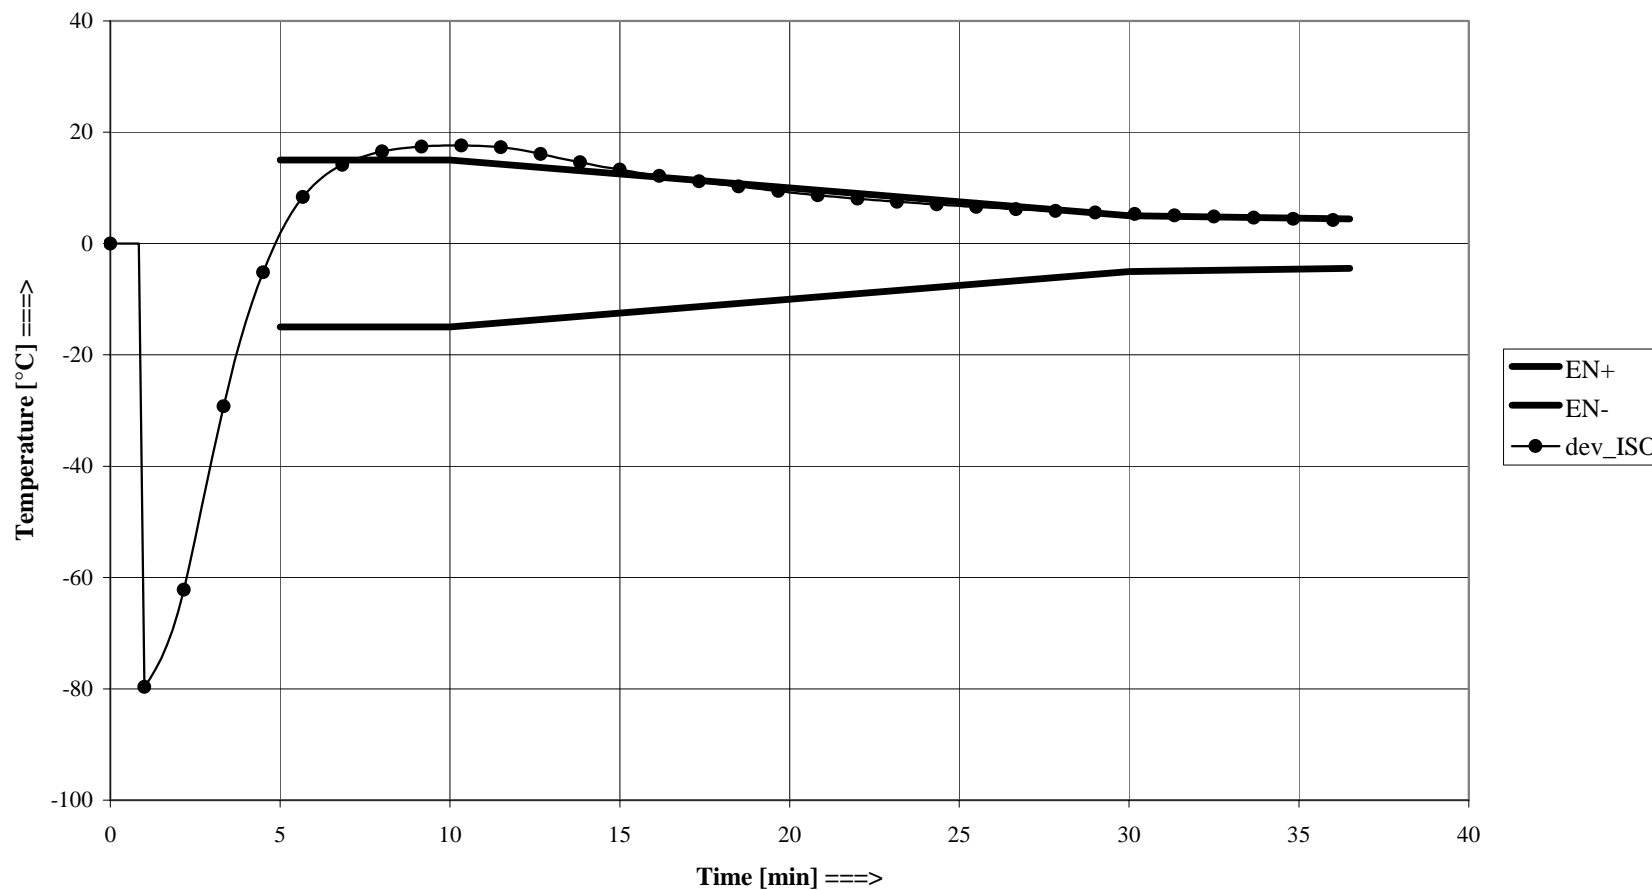
Figuur B3: Deviation furnace

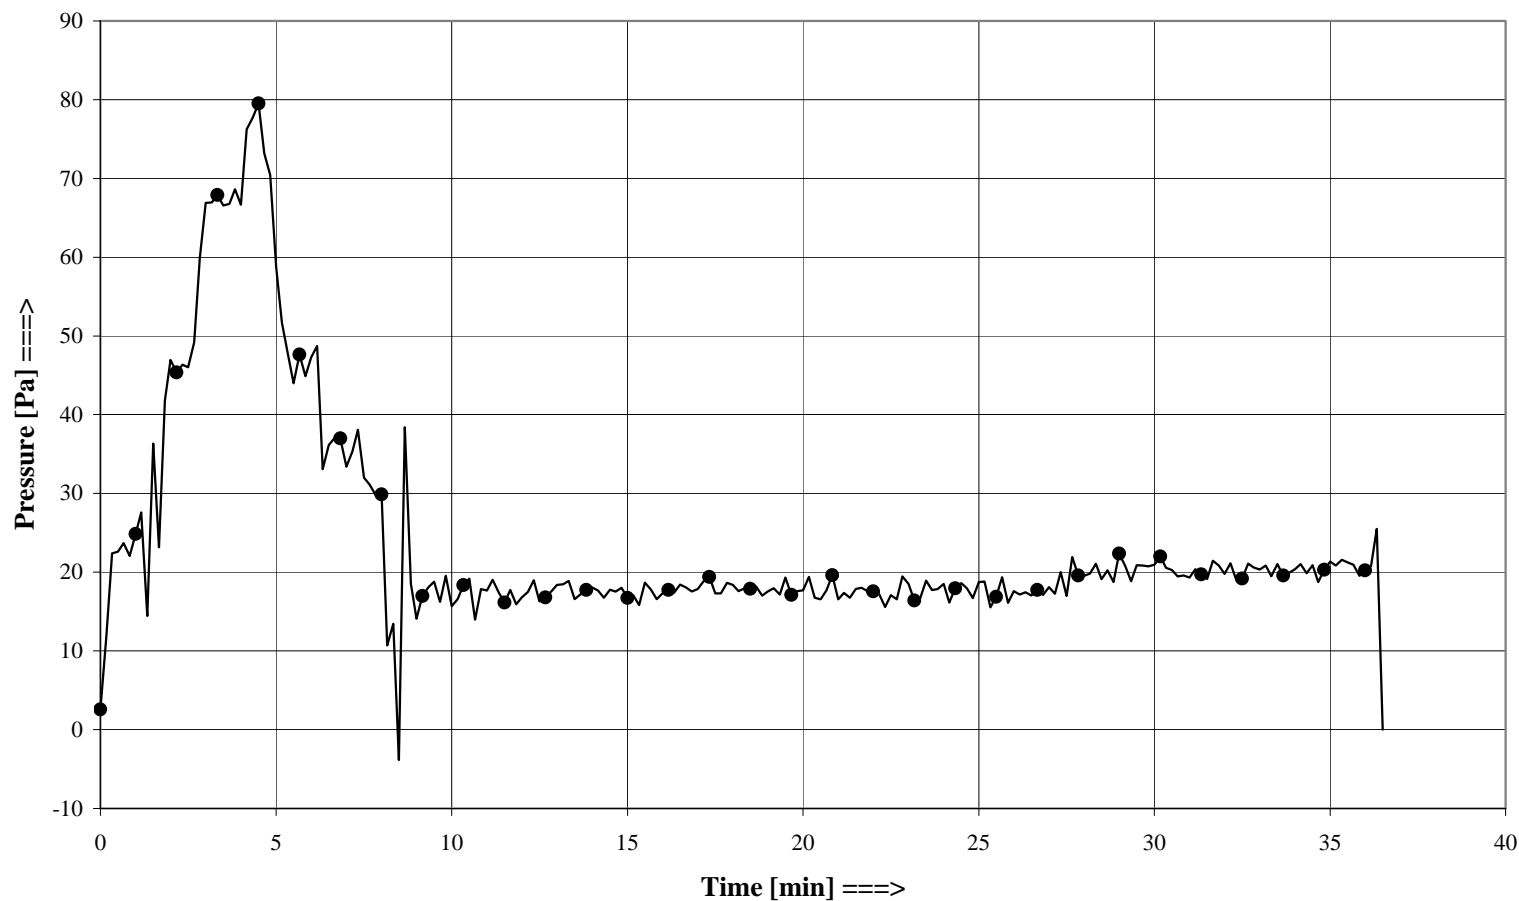
Figuur B4: Furnace pressure

The test was performed under the conditions as specified in EN 1365-2: 1999, using the standard fire curve. The specimen was heated from the underside only. The aim for the furnace pressure, as measured 100 mm below the ceiling, was 20 Pa.

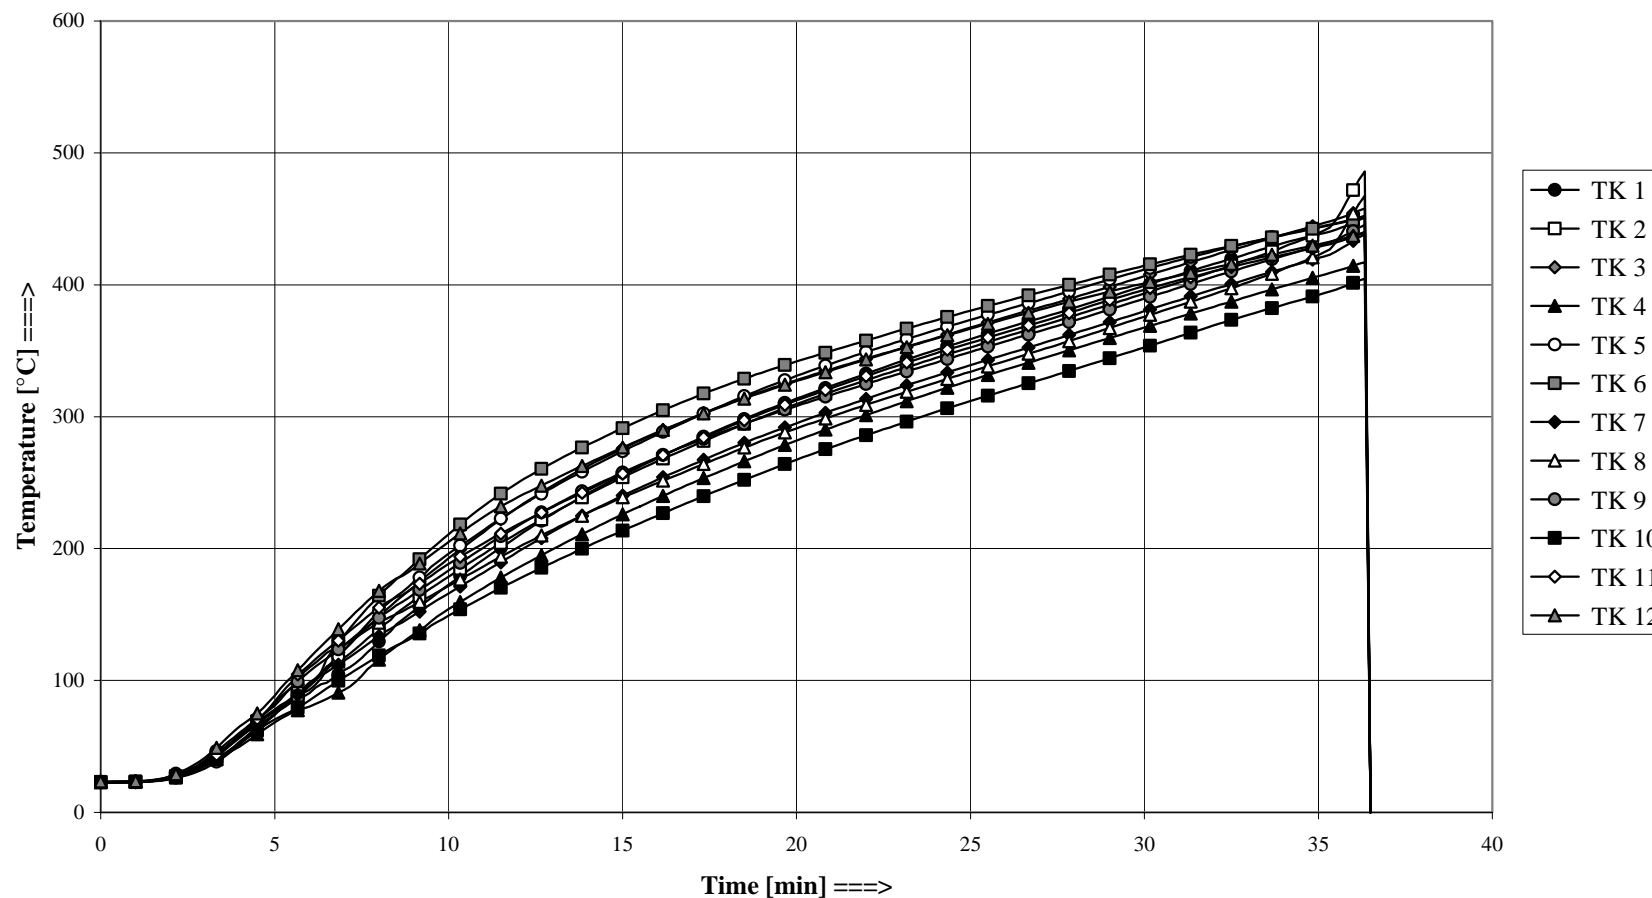
Figuur B5: Steel temperatures

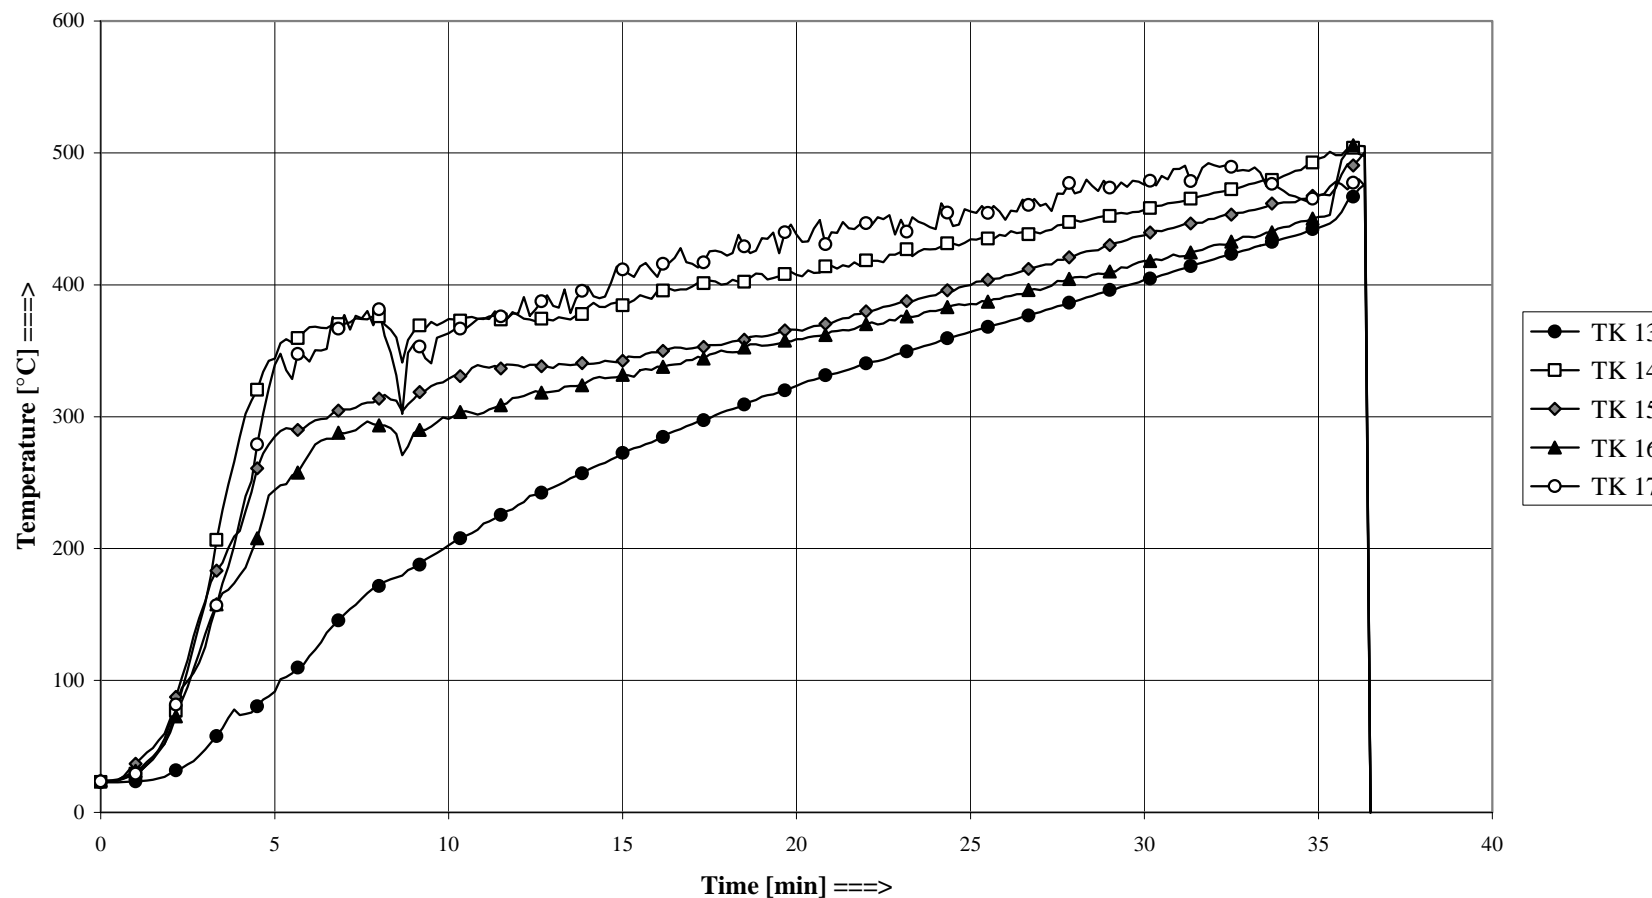
Figuur B6: Cavity temperatures

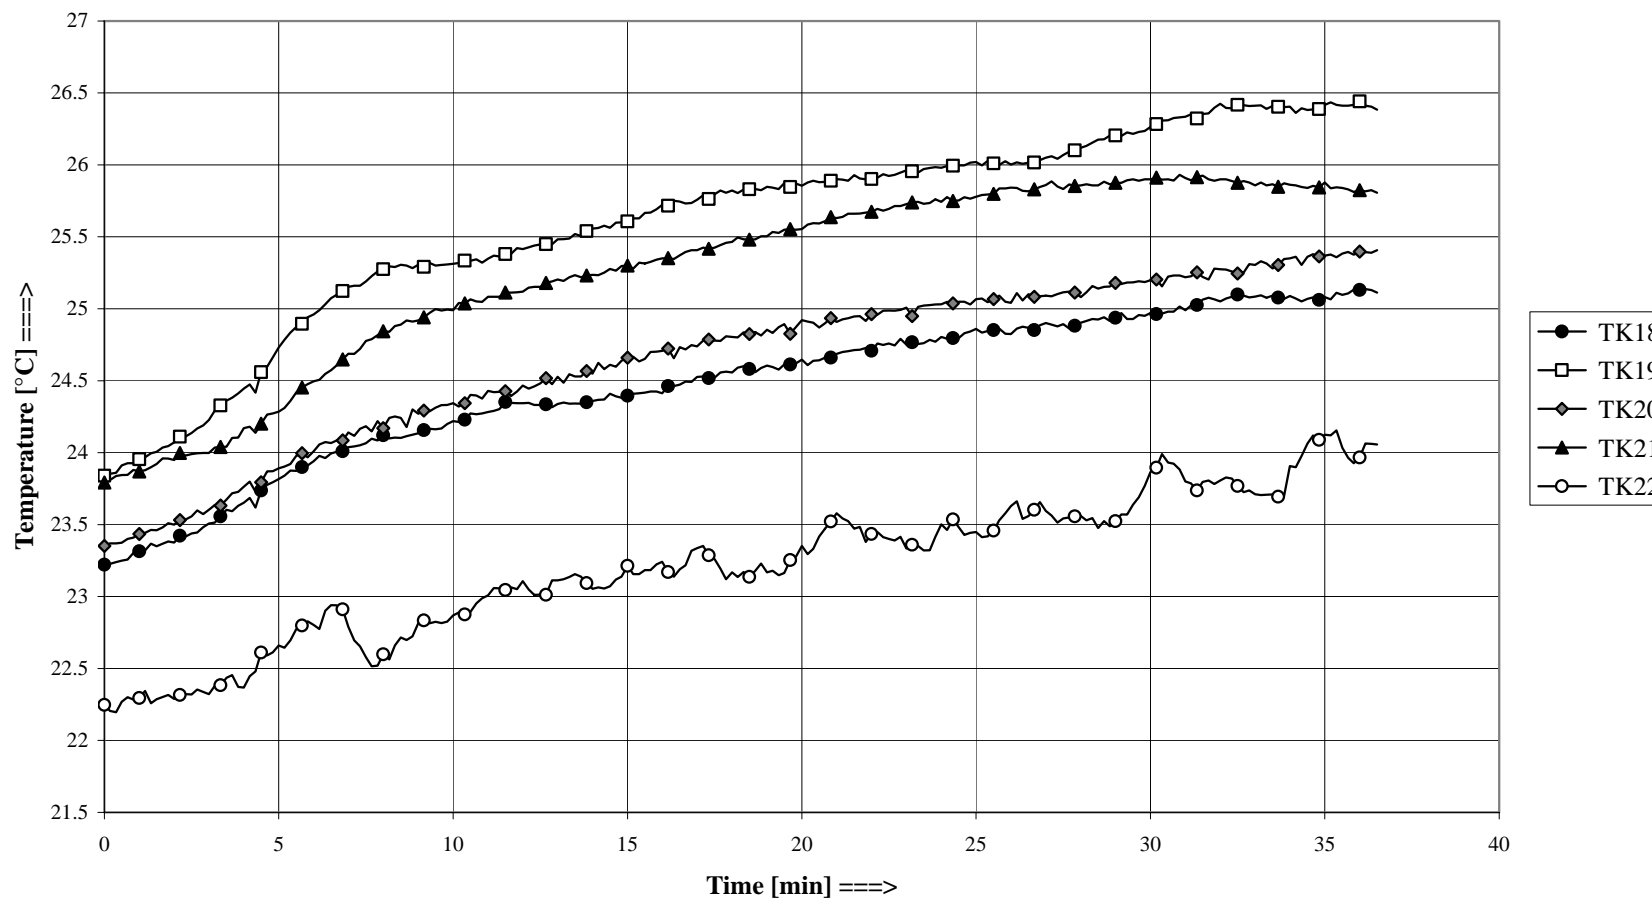
Figuur B7: Surface temperatures

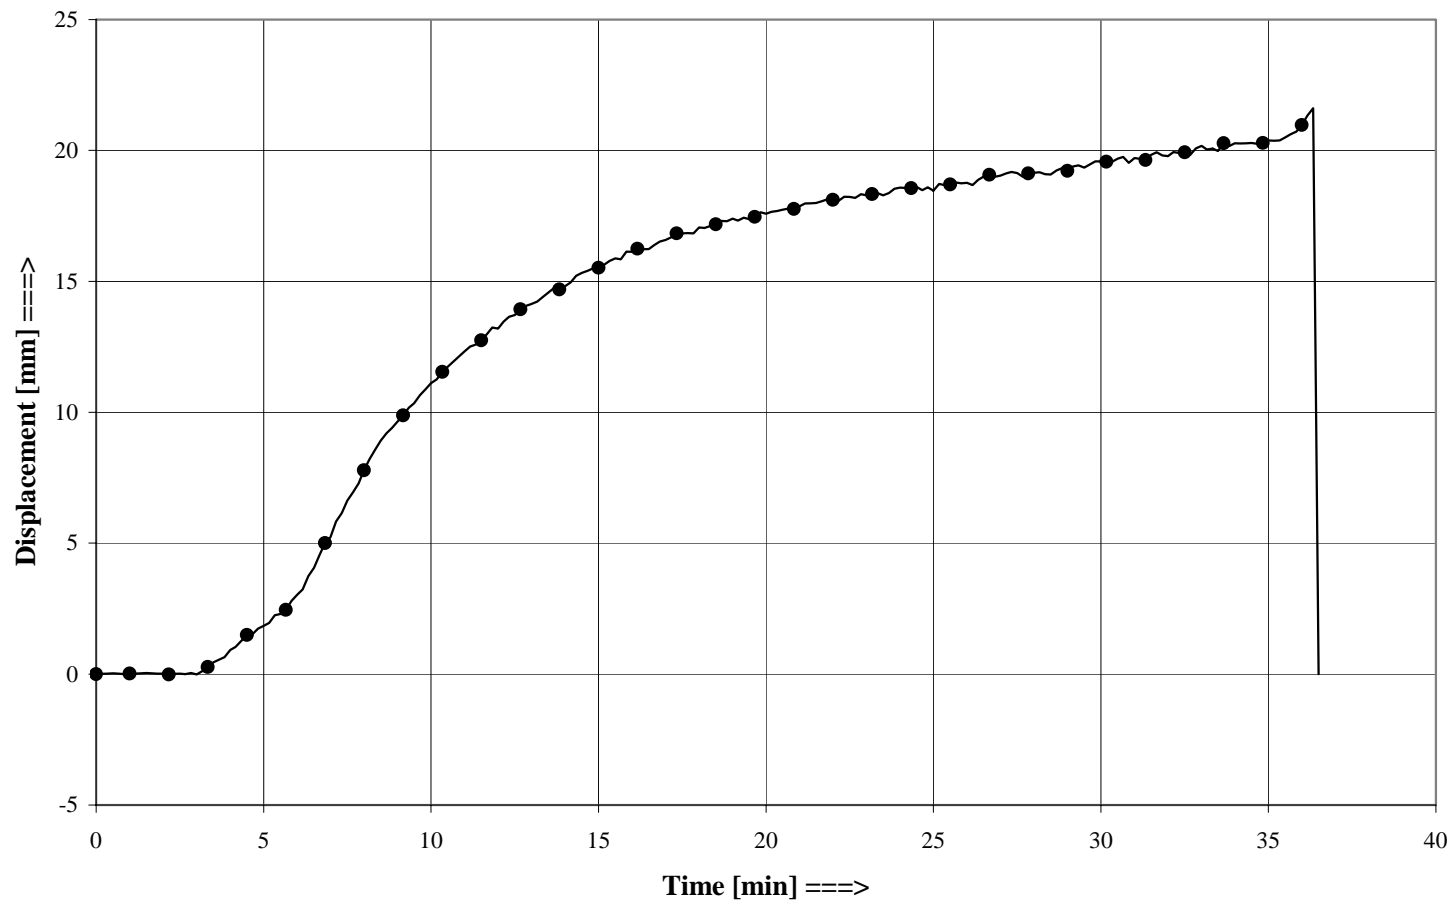
Figuur B8: Displacement

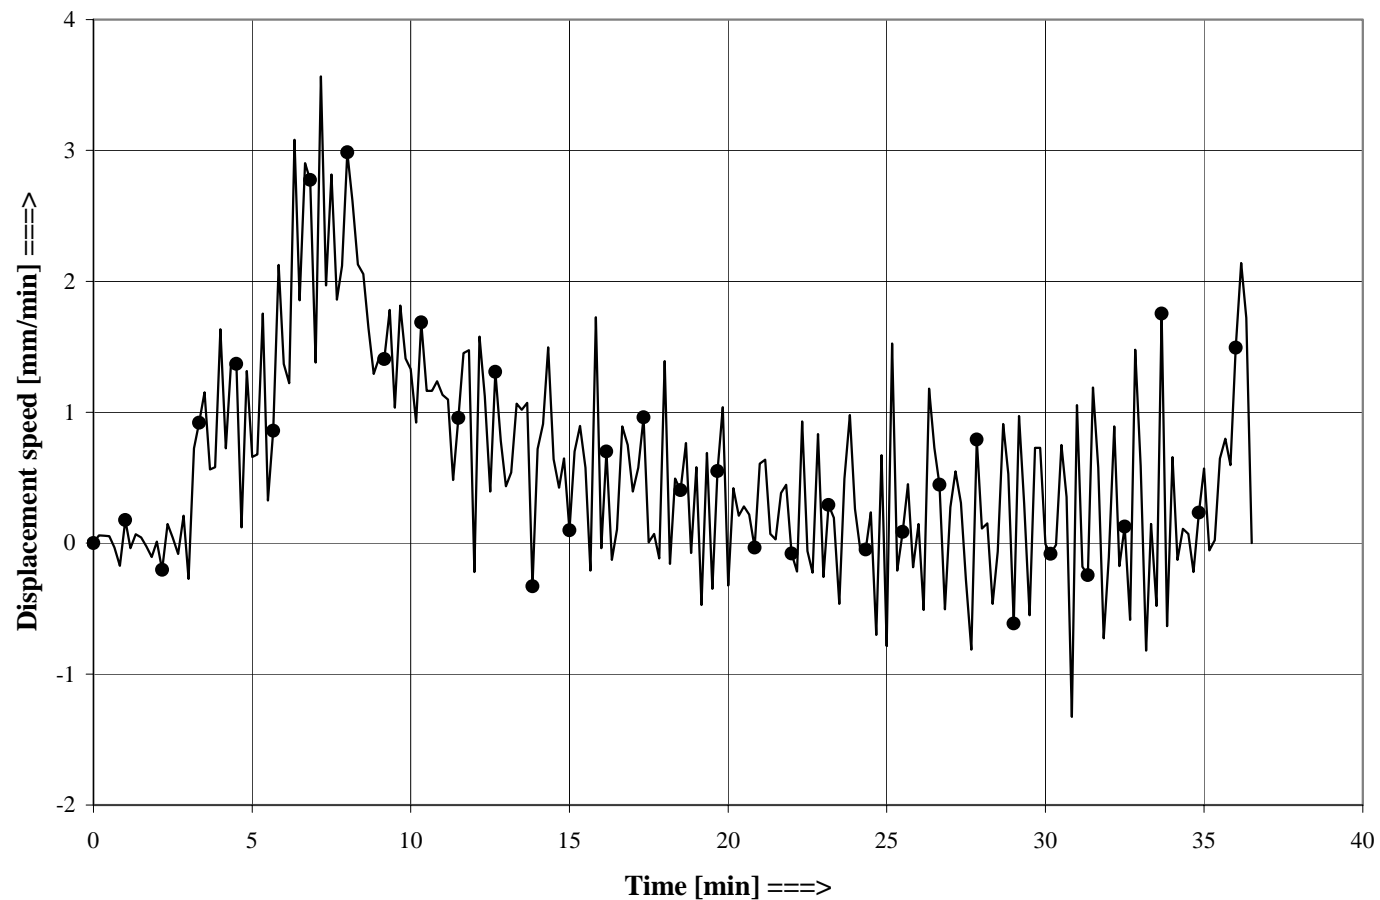
Figure B9: Displacement speed

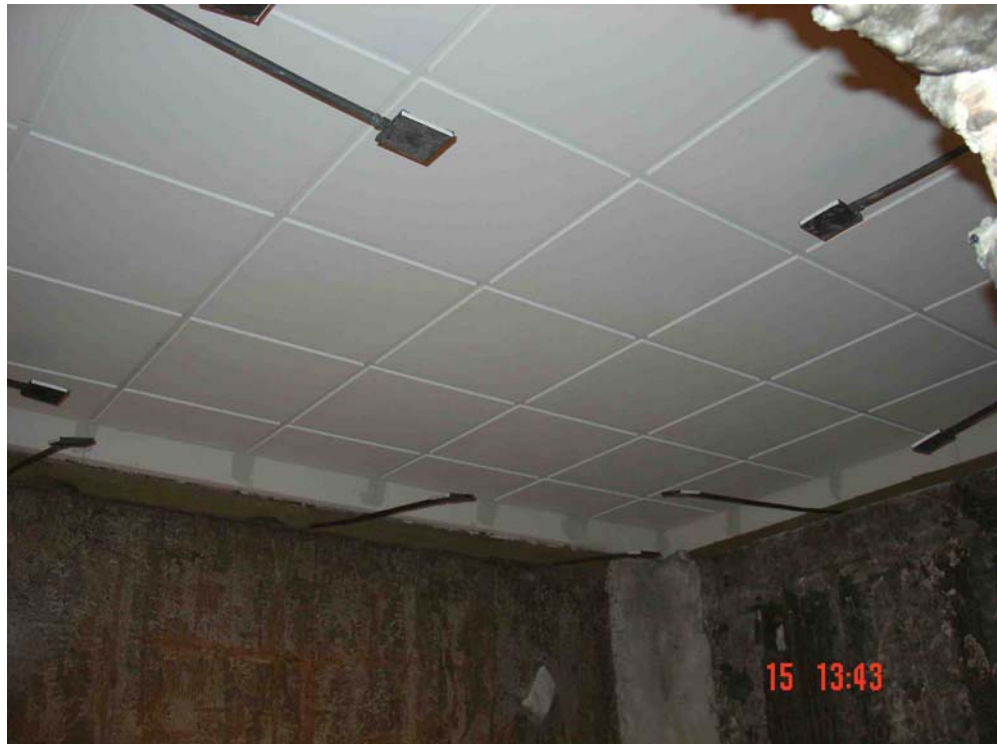
Figure C1 Specimen from the heated side before the test

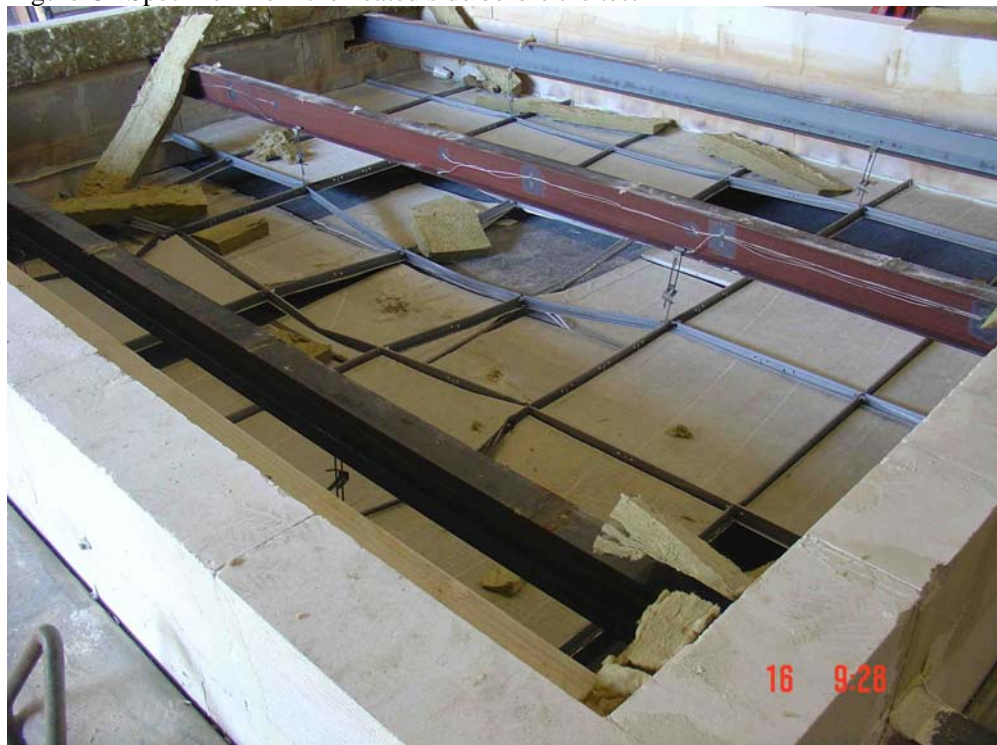
Figure C2 Specimen after the test looking into the cavity

Time [min]	Observation
0	Start of heating. Only 1 of the 6 selected burners operate.
1	4 of the 6 selected burners operate
5	6 of the 6 selected burners operate
7	At the location A, near the firebreak, the main profile is bent. An opening has been created to the cavity. At the location B the wall profile is deformed in such a way that the ceiling tile is not correctly on its place
34	All requirements are fulfilled and no ceiling tile has fallen from the grid
35	The end of the heating after consulting the sponsor.
